**BASRAH COURTHOUSE CONSTRUCTION AND  
BASRAH COURTHOUSE WITNESS  
PROTECTION FACILITY  
BASRAH, IRAQ**

**SUSTAINMENT ASSESSMENT**

**SIGIR PA-08-159**

**APRIL 22, 2009**

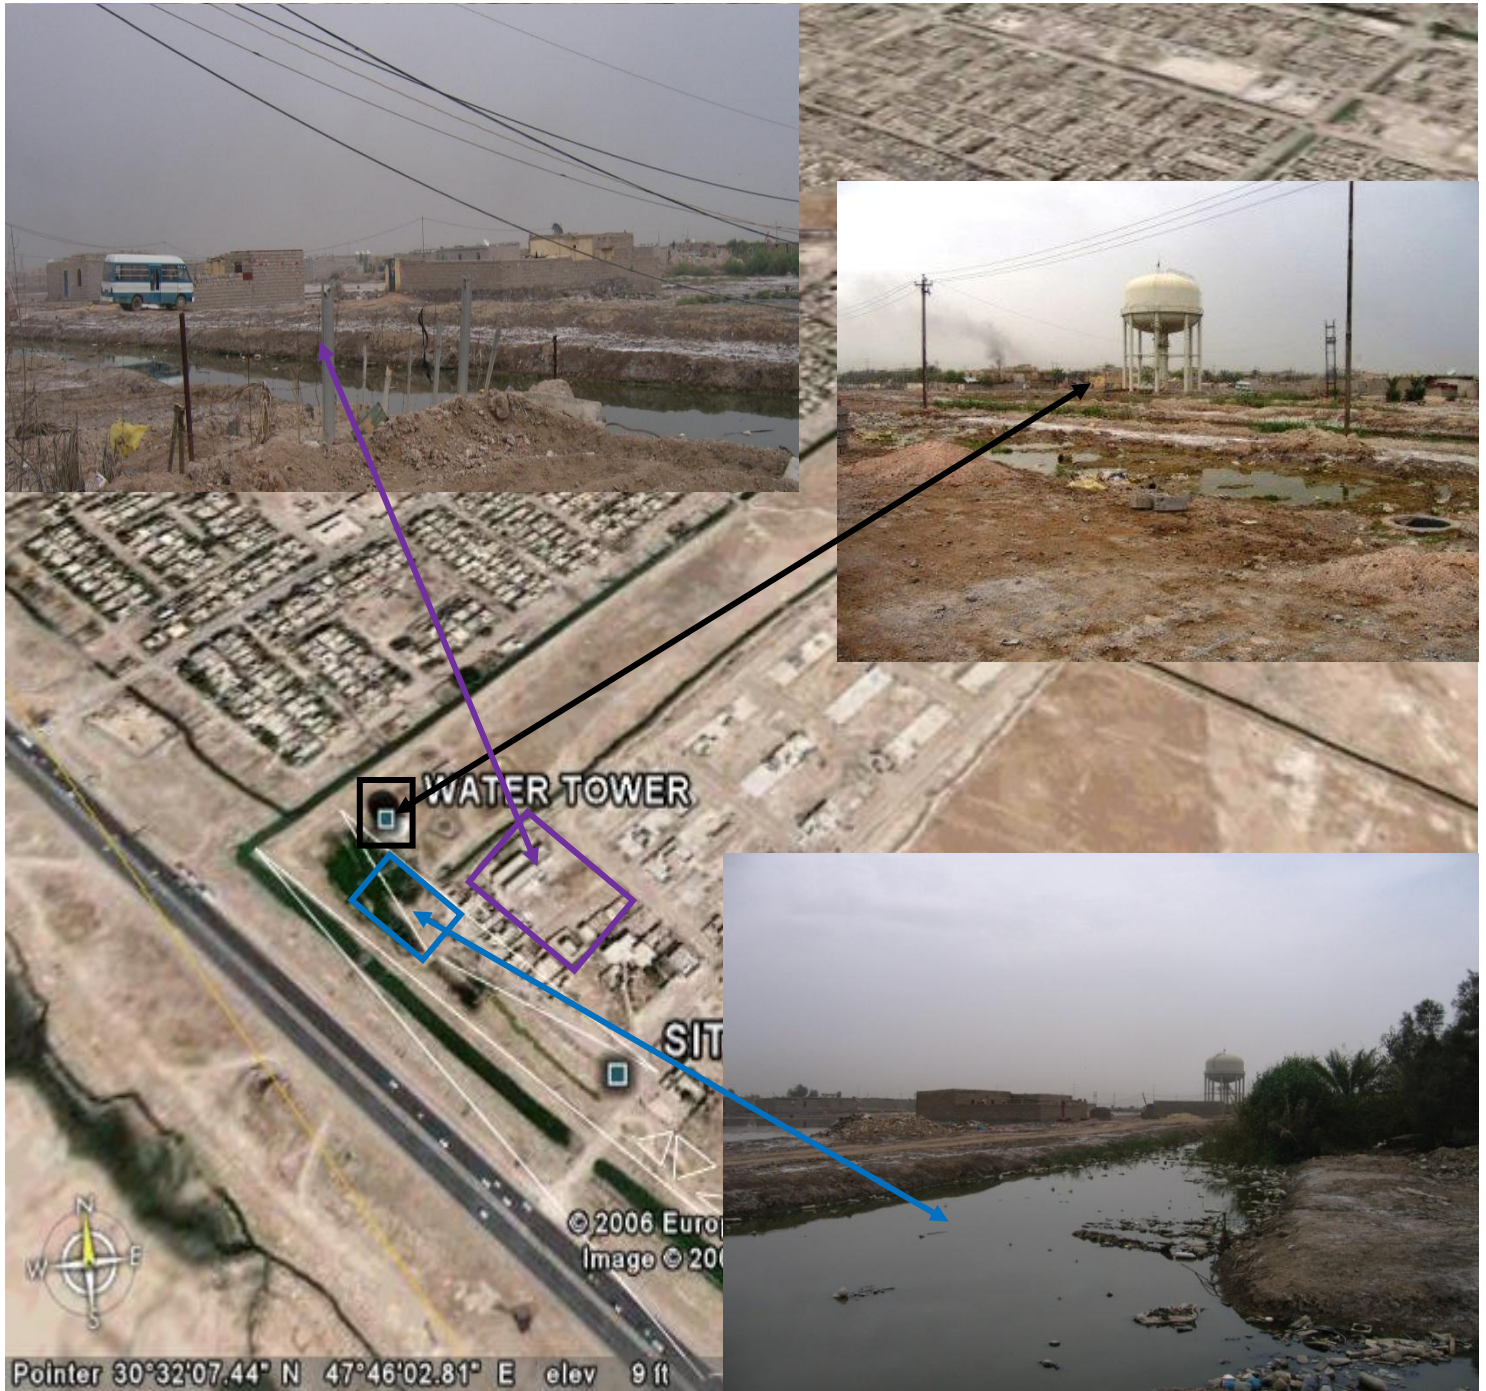
**Figure 1. Location of the courthouse project prior to construction  
(Aerial and photos courtesy of GRS)**

The site is flat with domestic dwellings bordering it on its northwest, northeast, and southeasterly sides. The main feature to the site is the prominent water tower, which is set back approximately 150 meters (m) and is visible from approximately 1 kilometer away (Figure 1).

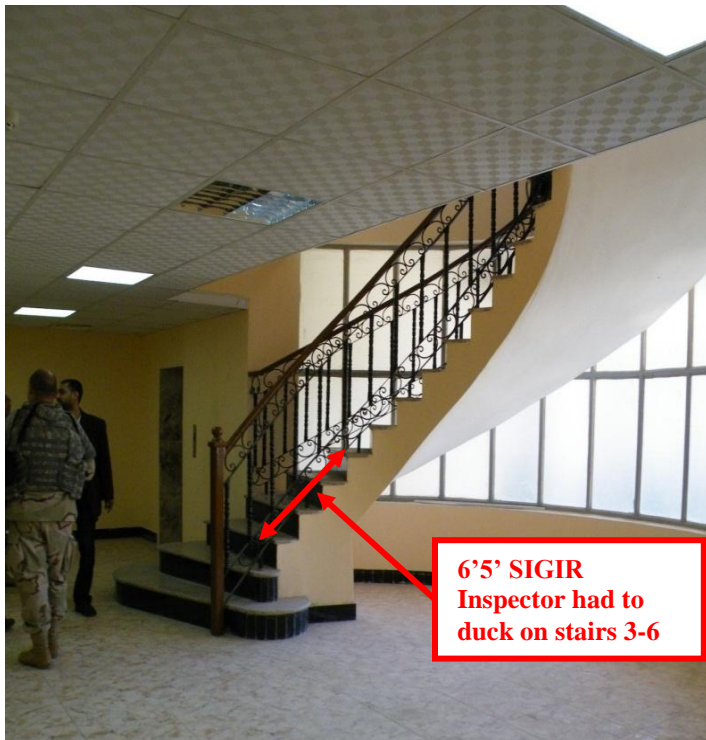
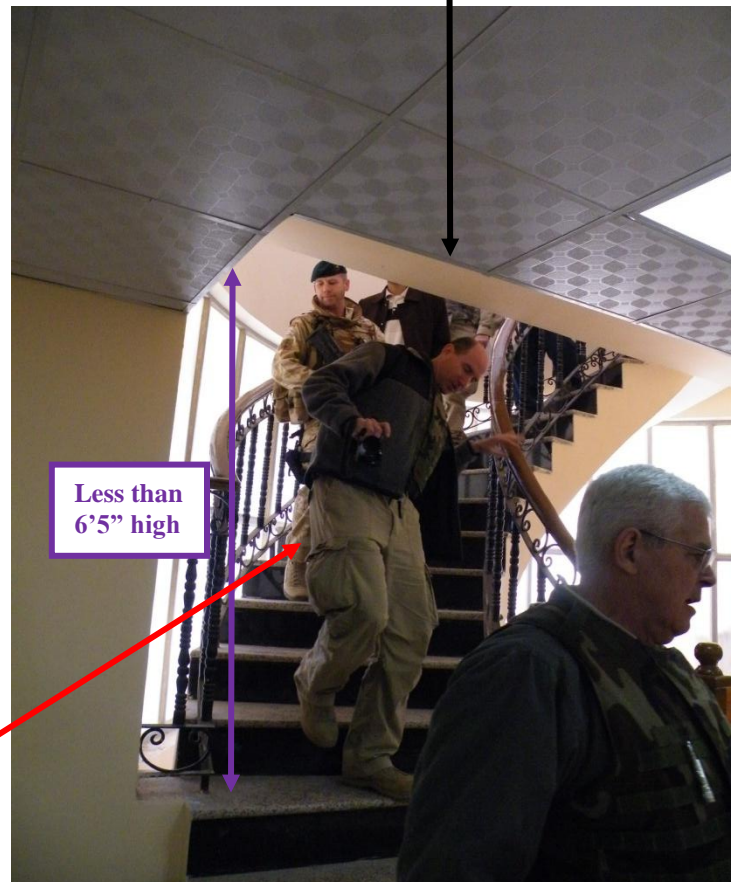
Site Photos 1 and 2. Spiral staircase and SIGIR Inspector ducking to avoid the false ceiling

SIGIR's review of the architectural drawings, the GFDs apparently did not take into account the loss in headroom that resulted from the installation of the false ceiling. This problem was most likely caused by a combination of designer oversight and small changes in construction. SIGIR determined that this error is a hazard to people using the stairs and should be addressed.<sup>9</sup>

<sup>2</sup> Originally, SIGIR intended to make a recommendation to correct this design error for all future courthouse projects; however, during the exit conference with GRD for this project, GRD representatives stated that all courthouse facilities have either already been constructed or were too far along in construction to make such a change in design. GRD representatives stated that they will investigate the possibility of posting warning signs on the staircase regarding this issue.

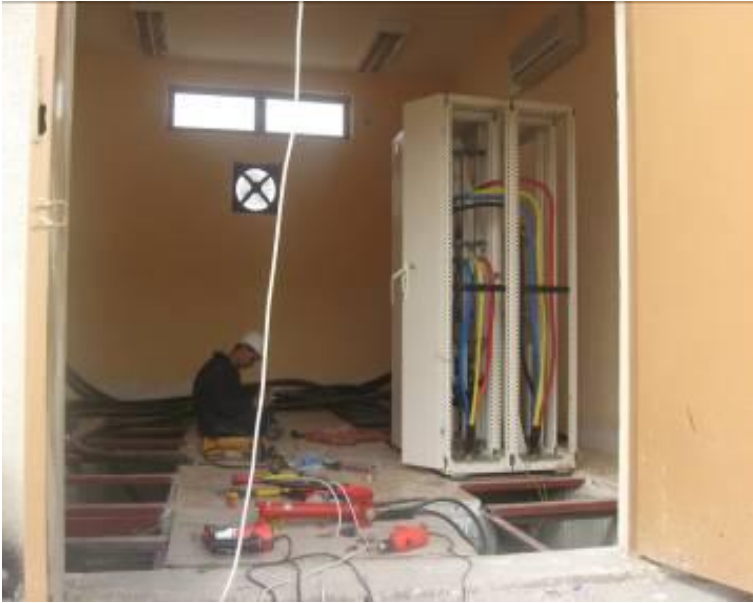
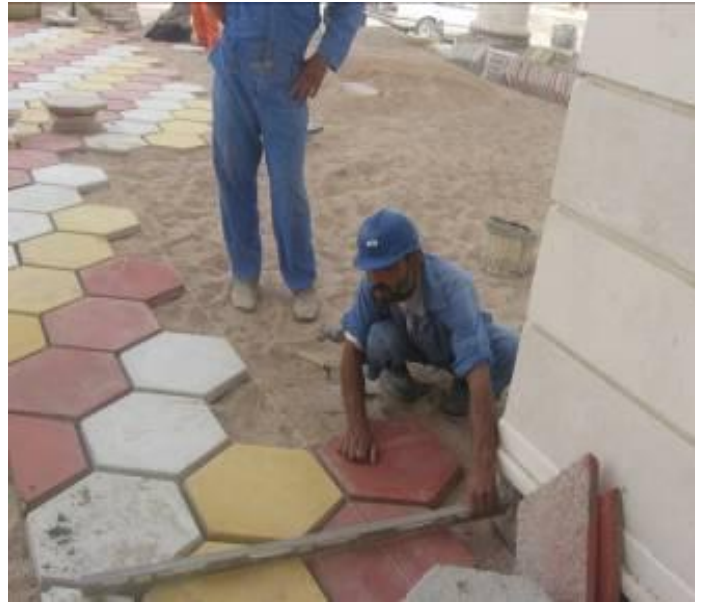
**Site Photos 3 and 4. Installation of electrical wiring and mosaic tile, respectively  
(Courtesy of GRS)**

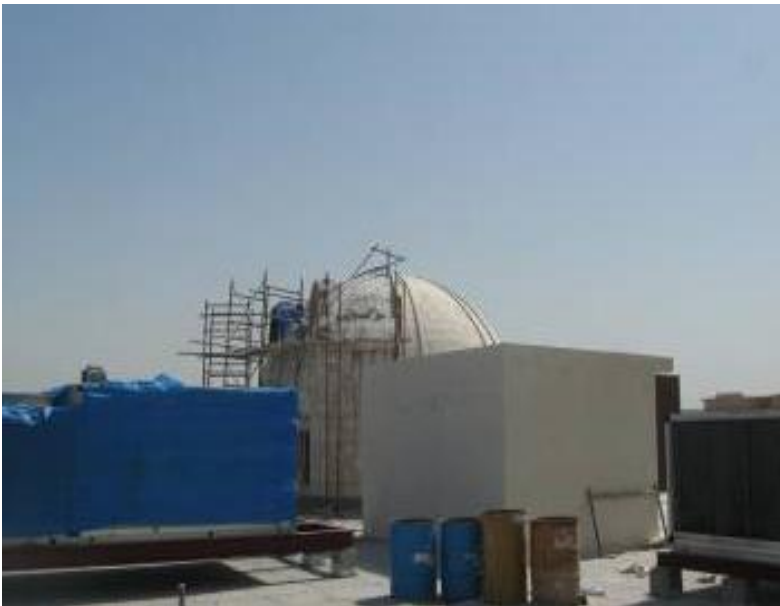
**Site Photo 5. Stone covering process for the courthouse dome  
(Courtesy of GRS)**

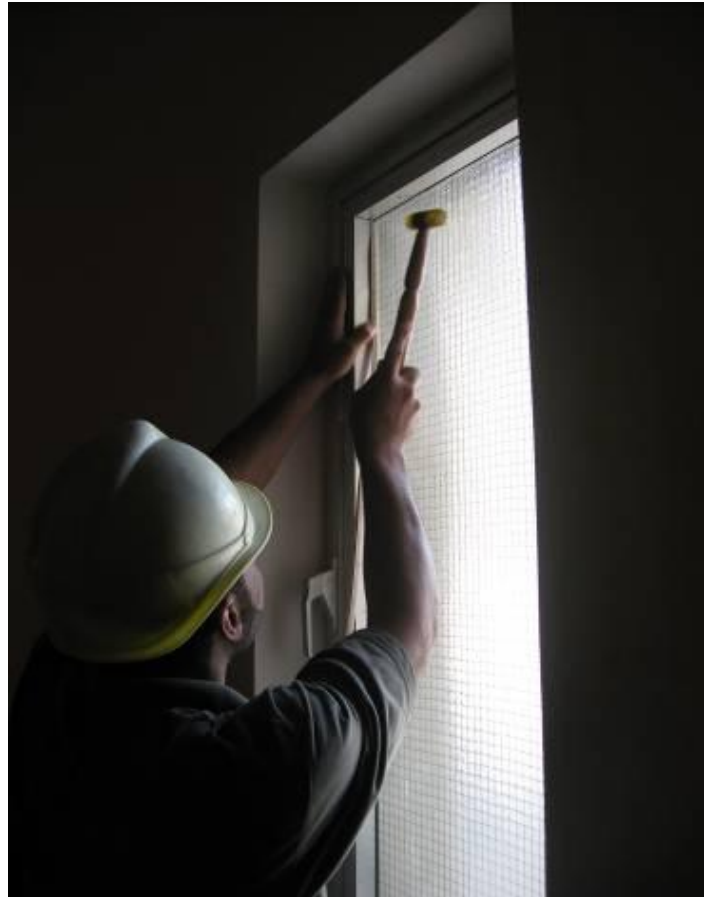
**Site Photo 6. Installation of ballistic glass for windows**

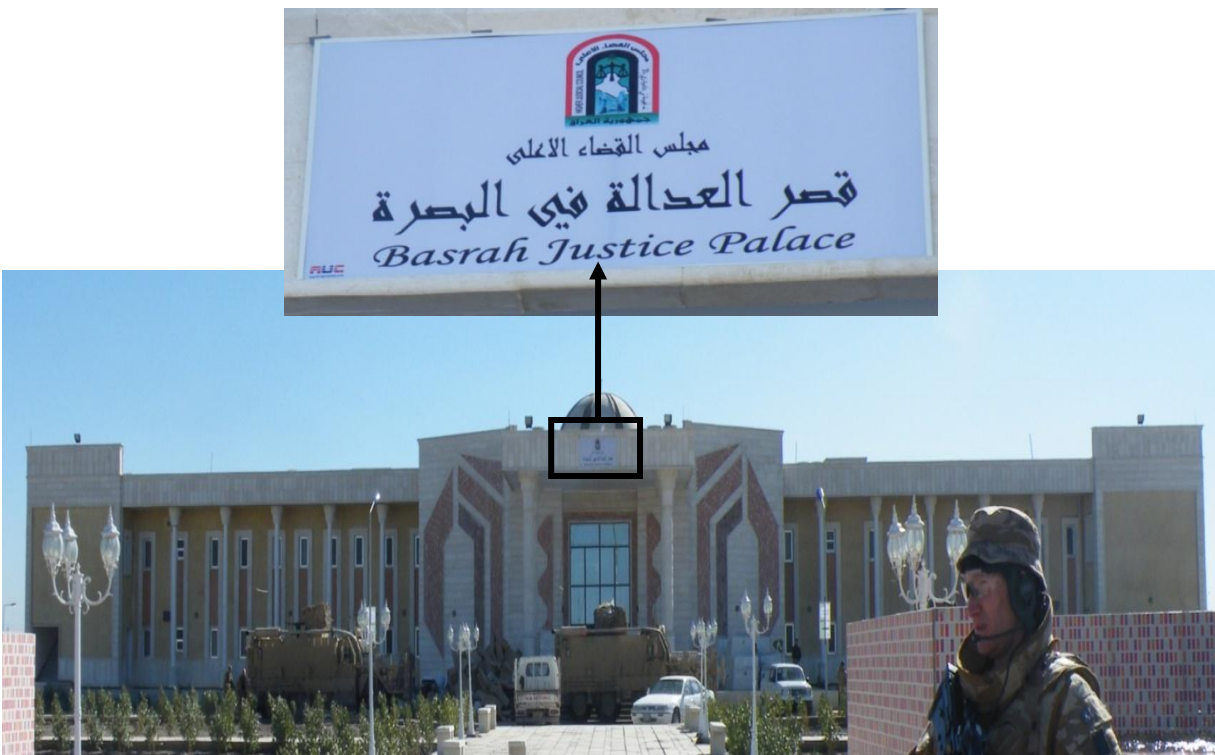
The courthouse building's exterior consists of 7m tall pillars, unique elongated ballistic windows, and a decorative stone façade (Site Photo 7). The contractor improved the more basic architectural drawings provided in the GFDs by adding attractive patterns to the stone façade. These stone patterns, along with the four larger diameter pillars and reflective glass, accentuate the main entrance to the building. According to courthouse personnel, the addition of the traditional front courthouse steps ensure visitors they are entering a building of significance.

Site Photo 7. View of entrance to the courthouse building

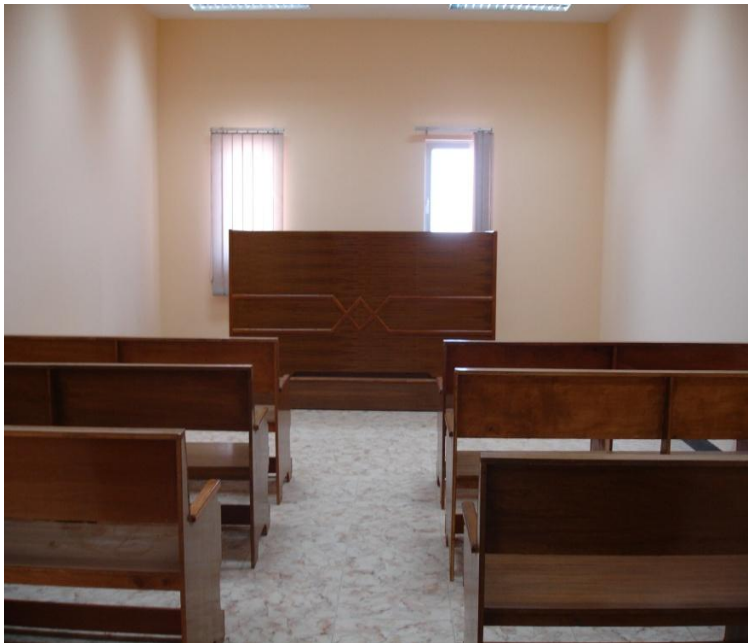
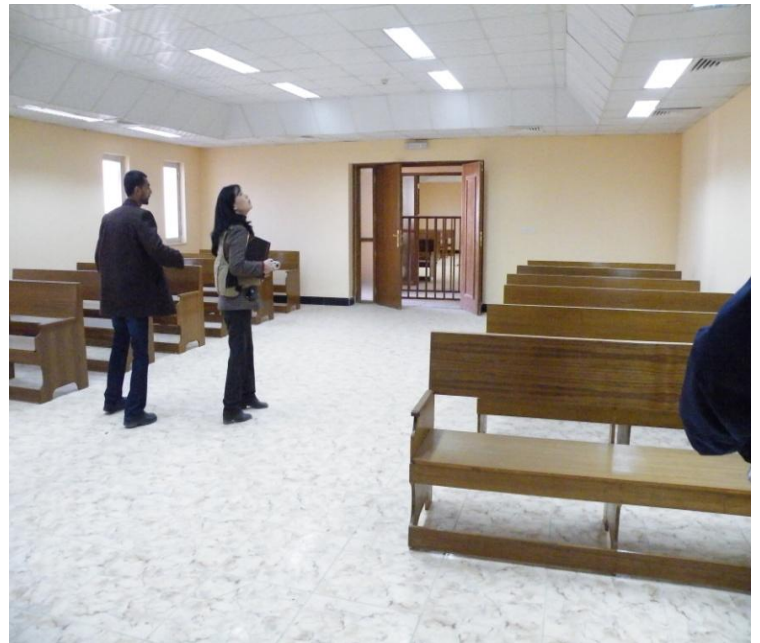
During the site visit, SIGIR inspected several large and small courtrooms. At the time of the site visit, Government of Iraq (GOI)-funded furniture was being installed inside the courtrooms (Site Photos 8 and 9). There appeared to be an adequate amount of lighting for both the large and small courtrooms. The courtrooms are of sufficient size to comfortably seat the judge, defendant, witnesses, and public. All observed work in the courtrooms appeared adequate and met the standards of the GFD. SIGIR did not find any noticeable defects associated with the quality of workmanship.

**Site Photos 8 and 9. GOI-provided furniture for the courthouse courtrooms**

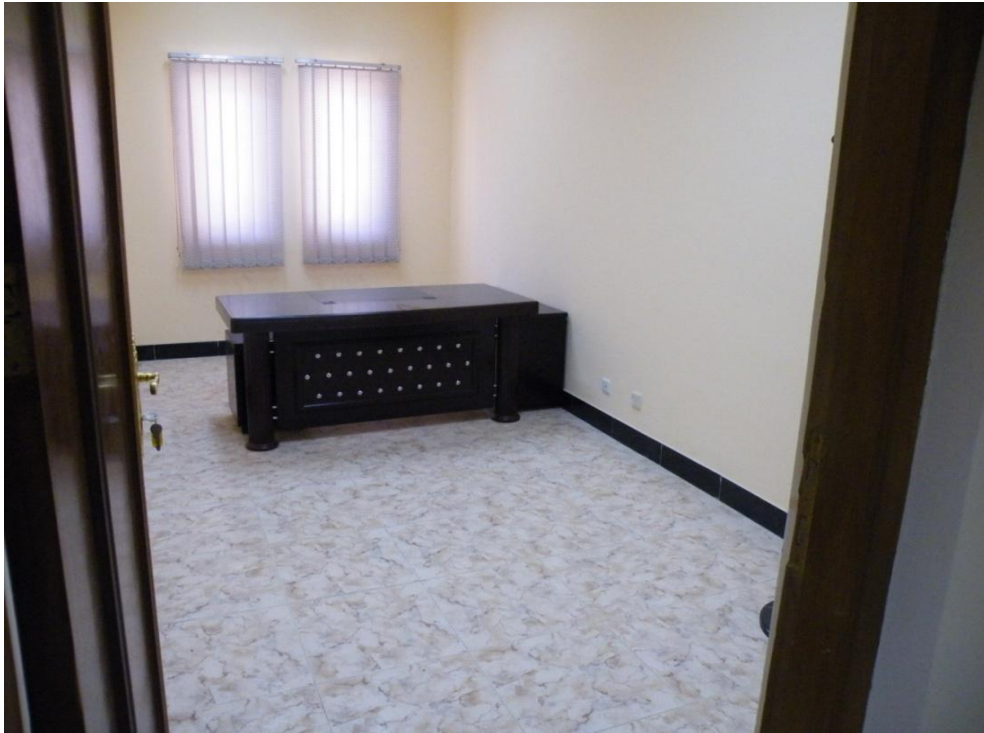
During the site visit, SIGIR inspected several offices to be used by judges, lawyers, and administrative staff. At the time of the site visit, the GOI-funded furniture was being installed (Site Photo 10). There appeared to be an adequate amount of lighting and

electrical outlets in the offices. All observed work in the offices appeared adequate and met the standards of the GFD. SIGIR did not find any noticeable defects associated with the quality of workmanship.

**Site Photo 10. Size of a typical judge's office (with furniture from the GOI)**

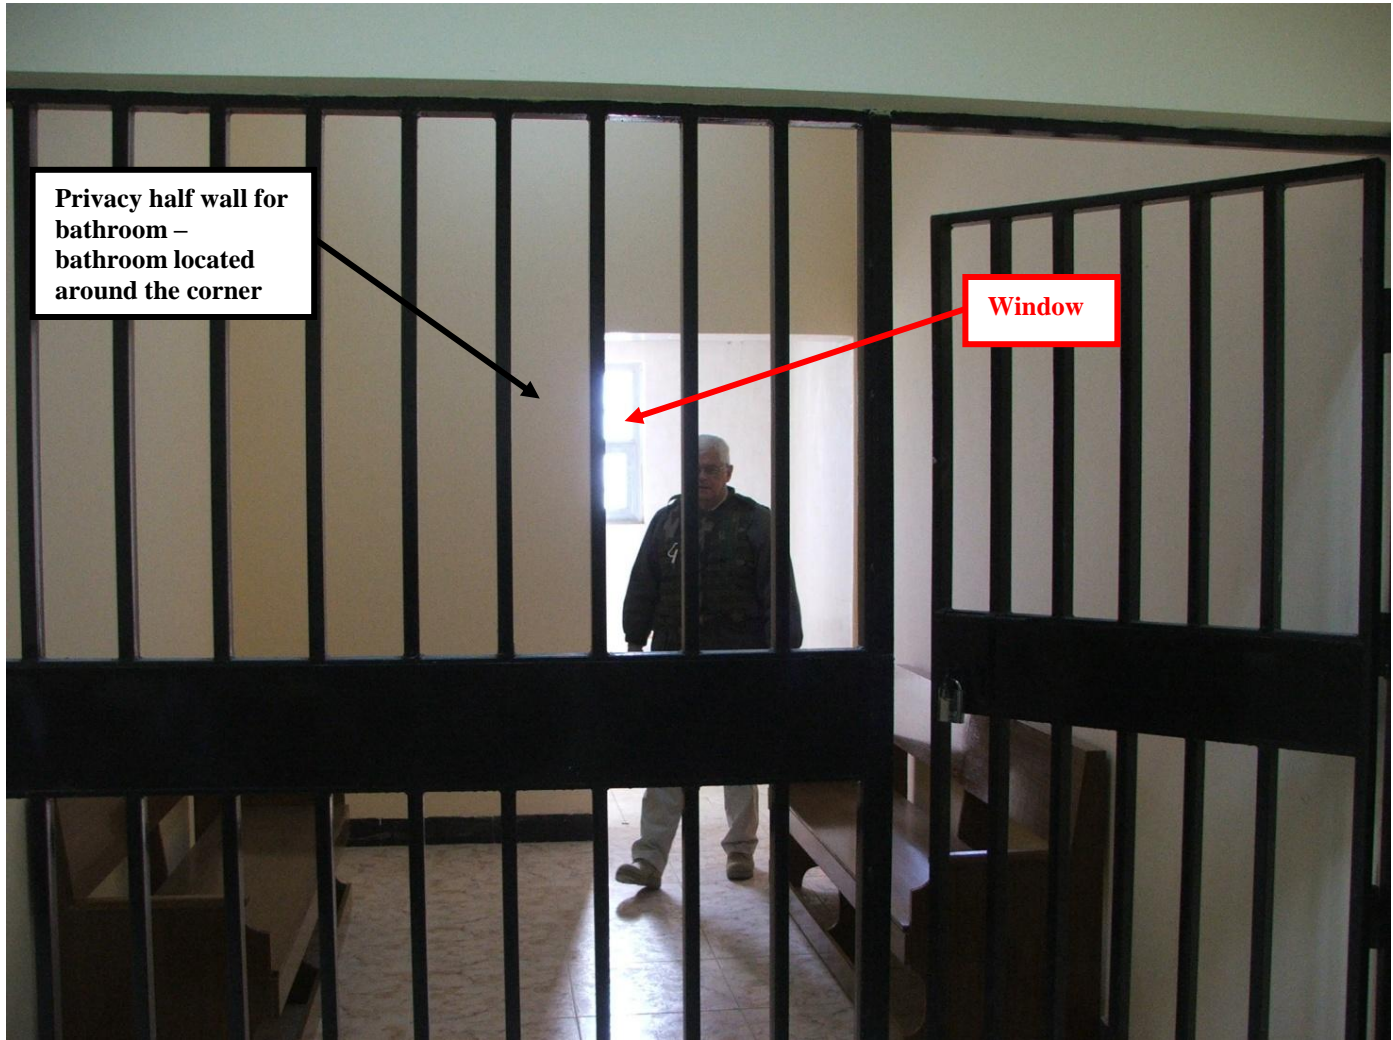
SIGIR found the bathroom fixtures to be poor-quality products, which will require continuous maintenance and replacement to sustain operations. The cell door is steel barred and locked with a heavy duty padlock.

**Site Photo 11. Interior of holding cell (including privacy half wall for bathroom and window)**

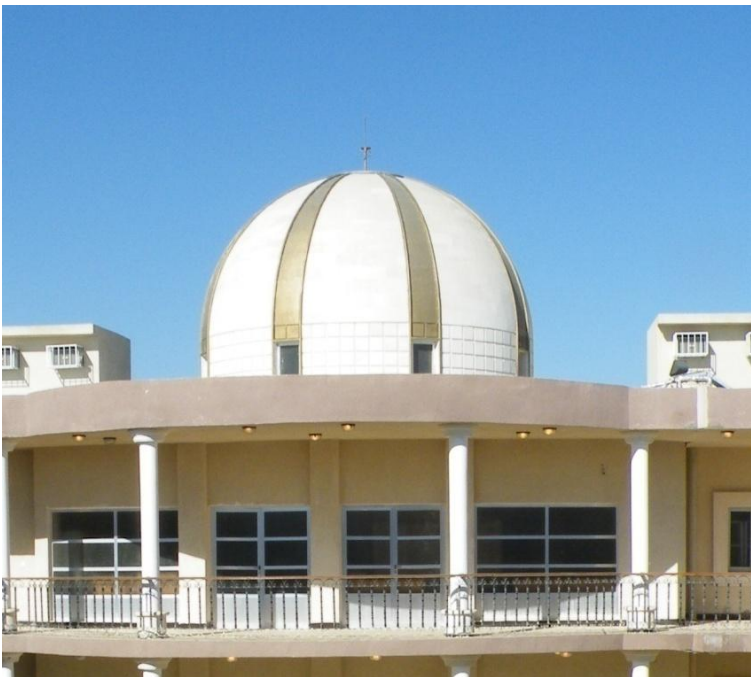
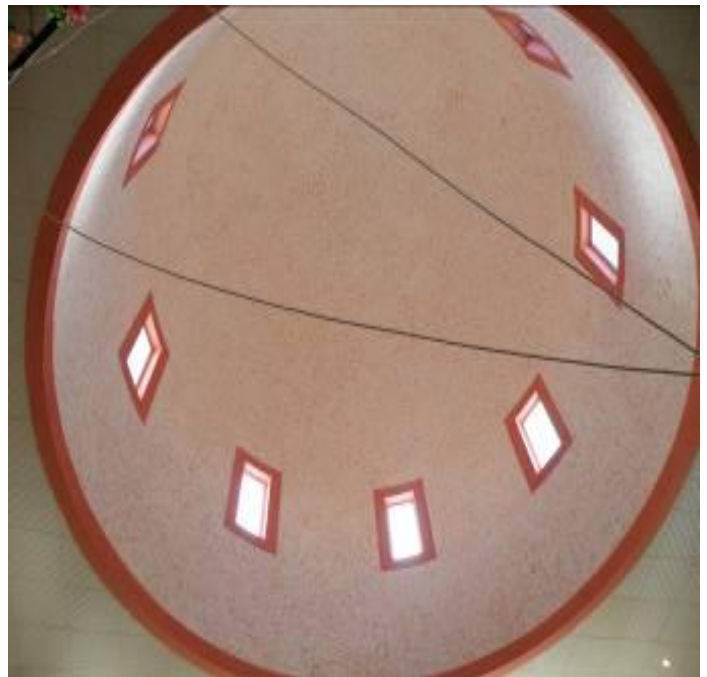
The dome is hand painted and includes windows for interior lighting (Site Photos 12 and 13). The dome and the view of the interior courtyard provide a dramatic first impression of the building. All observed exterior and interior work for both the rotunda and dome appeared adequate without any noticeable defects. The quality of workmanship, specifically the hand painted dome, was very good.

**Site Photos 12 and 13. Exterior and interior views of the courthouse dome**

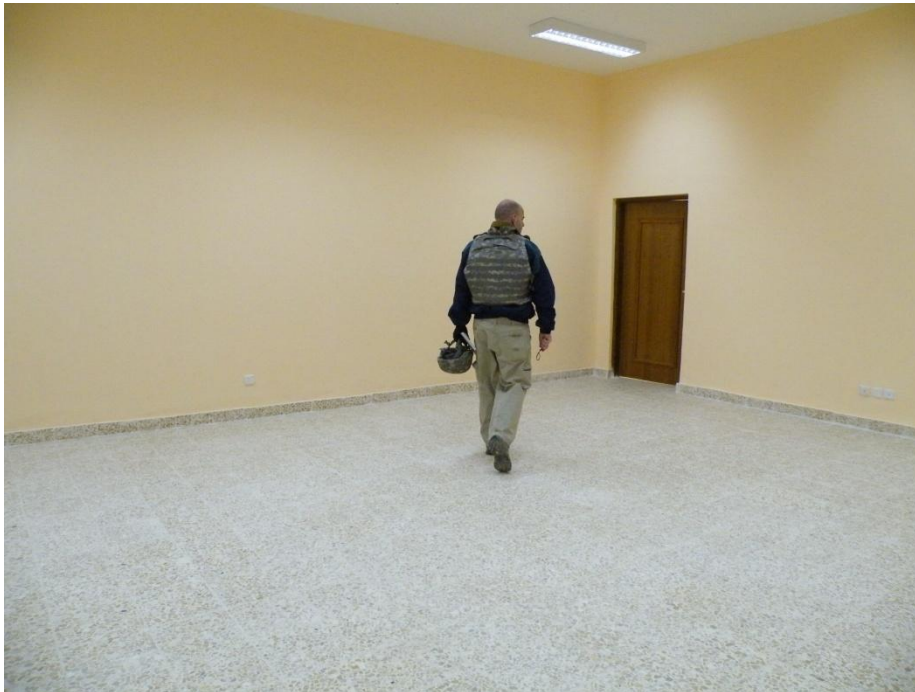
The facility has two single hotel-style rooms, which each consisting of a living room, bedroom, bathroom, and kitchen. These rooms are very spacious and will provide more than a sufficient amount of living space for its occupants (Site Photo 14). All observed work in the witness protection facility appeared adequate and met the standards of the GFD. SIGIR did not find any noticeable defects associated with the quality of workmanship.

**Site Photo 14. View of the interior of a single hotel-style room**

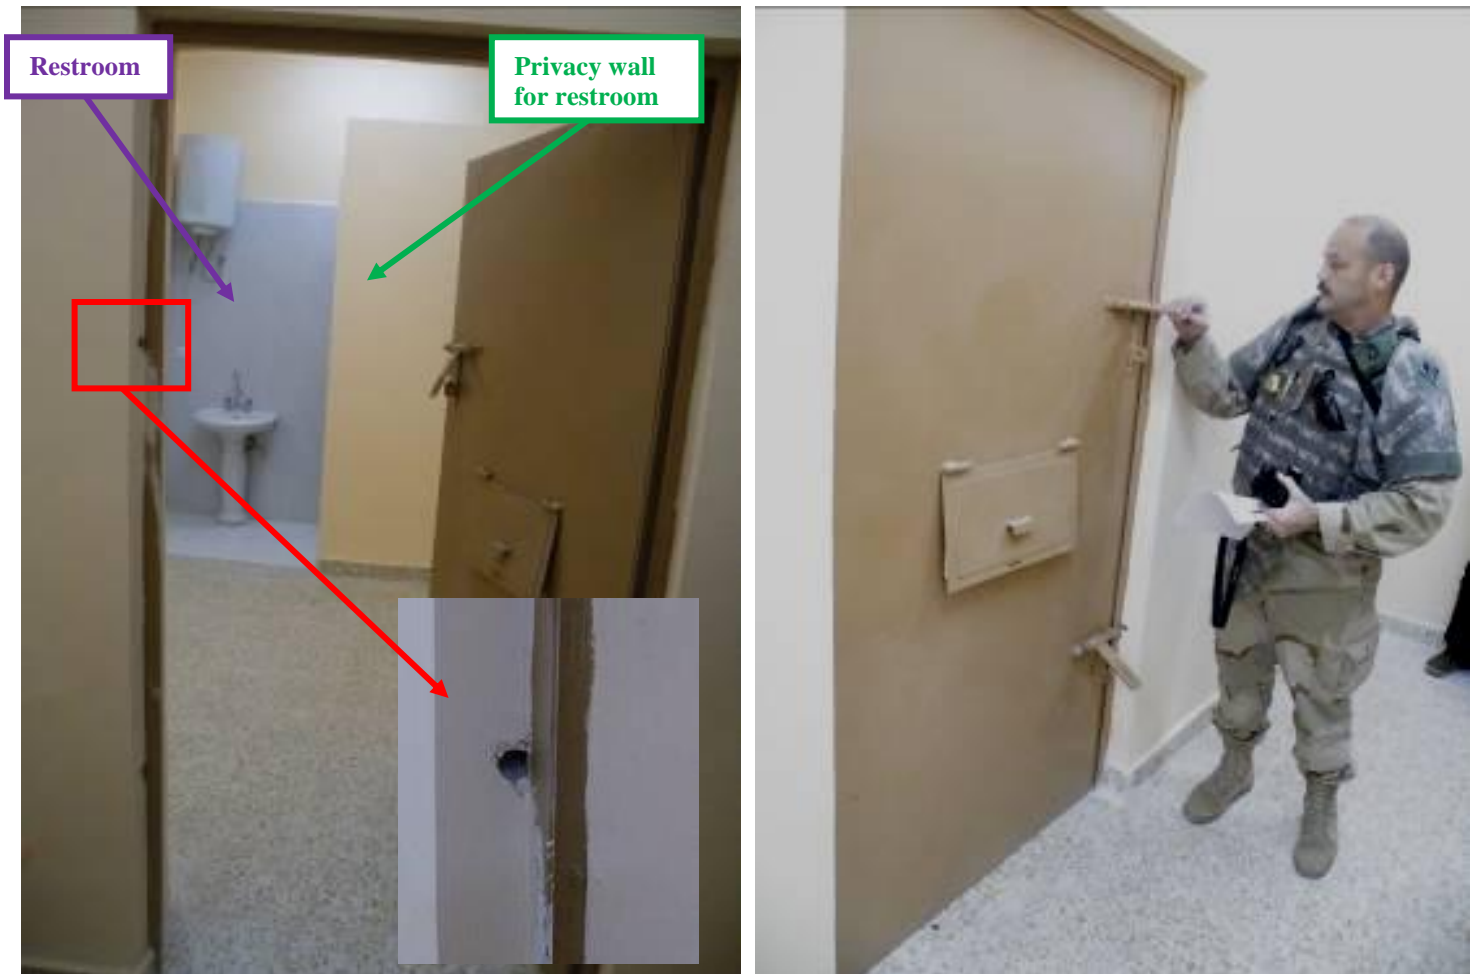
Separate male and female individual holding cells were constructed for defendants awaiting trial. Each holding cell included a restroom with a half wall to provide some privacy while using the restroom without completely obstructing the guard's view of the defendant inside the cell. SIGIR found the bathroom fixtures to be poor quality products, which will require regular maintenance and replacement to sustain operations. Each cell had a steel door and heavy duty locking mechanisms. The locking slide bar overlapped the door frame, but a simple hole was drilled into the plaster to allow the bar to slide into the wall (Site Photos 16 and 17). Considering defendants accused of serious crimes against the State will be held in these cells, SIGIR concludes a more durable solution to this issue should have been considered.

Site Photos 16 and 17. Holding cell door and locking mechanism

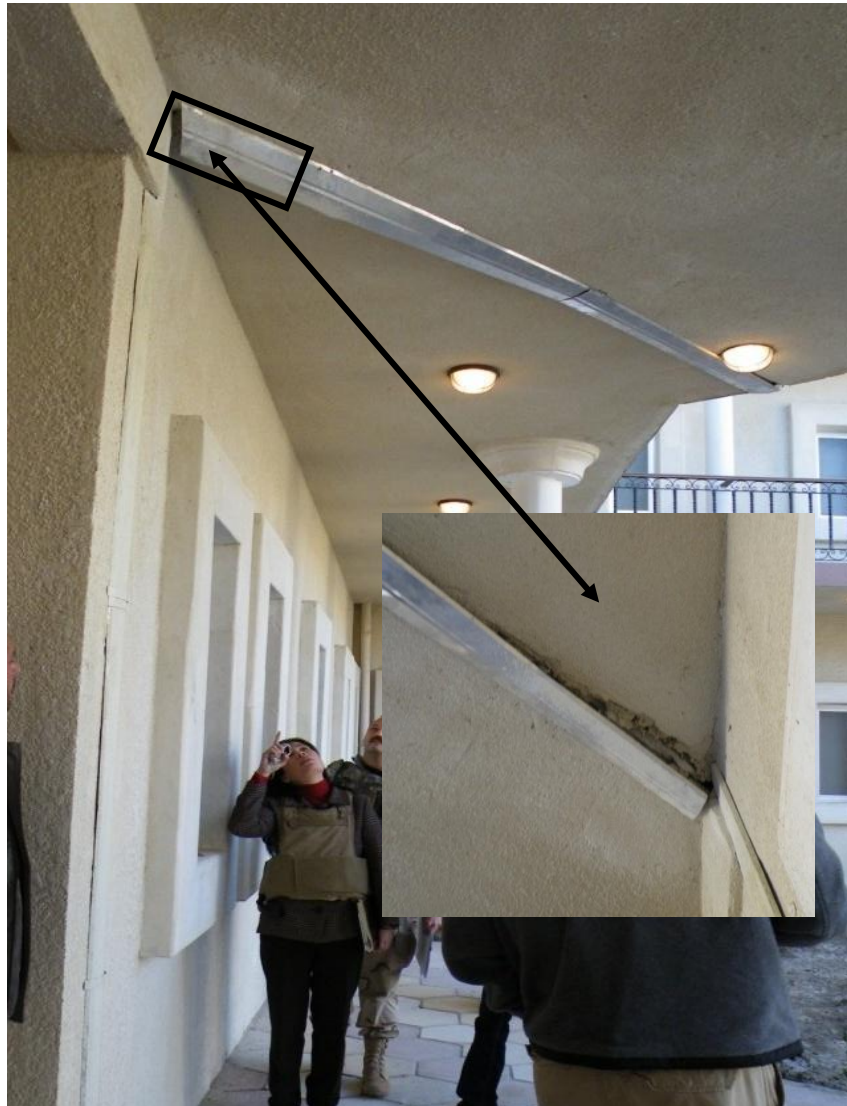
SIGIR identified poorly constructed expansion joints in the courthouse and hallway connecting to the witness protection facility. The expansion joints displayed cracking and crumbling of the exterior plaster finish. The contractor used aluminum covers to hide some of unsightly cracking and crumbling plaster (Site Photos 18-20).

**Site Photo 18. SIGIR Inspector identifying an exterior expansion joint crack of the courthouse building (inset – enlargement of specific area)**

1. Determine the extent of damage to the walls caused by poorly constructed expansion joints and take corrective actions as appropriate.
2. Place all exposed electrical wiring into conduit.
3. Determine the appropriate manner in which to provide two water-supply hookups to the washers and exhaust vents for the two dryers.

- Identify all poorly constructed expansion joints and damage to the walls and devise a solution with the contractor.
- Direct the contractor to enclose all exposed wiring inside an appropriate conduit.
- Determine the needs of the Ministry of Justice in terms of laundry facilities and act accordingly to ensure the realization of those functions and features.

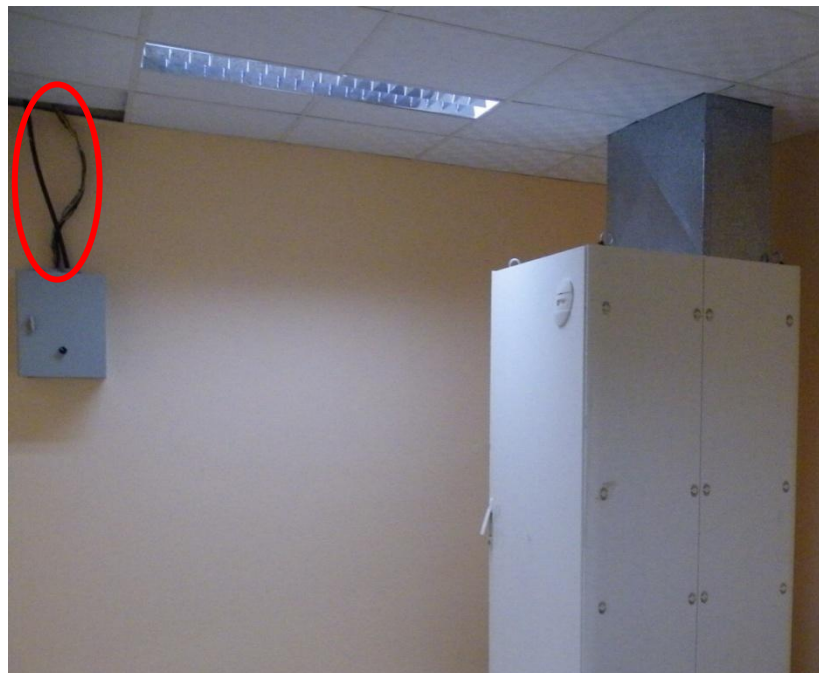
SIGIR identified instances of electrical wiring not in conduit in the courthouse (Site Photo 21).

**Site Photo 21. Electrical wiring not in conduit**

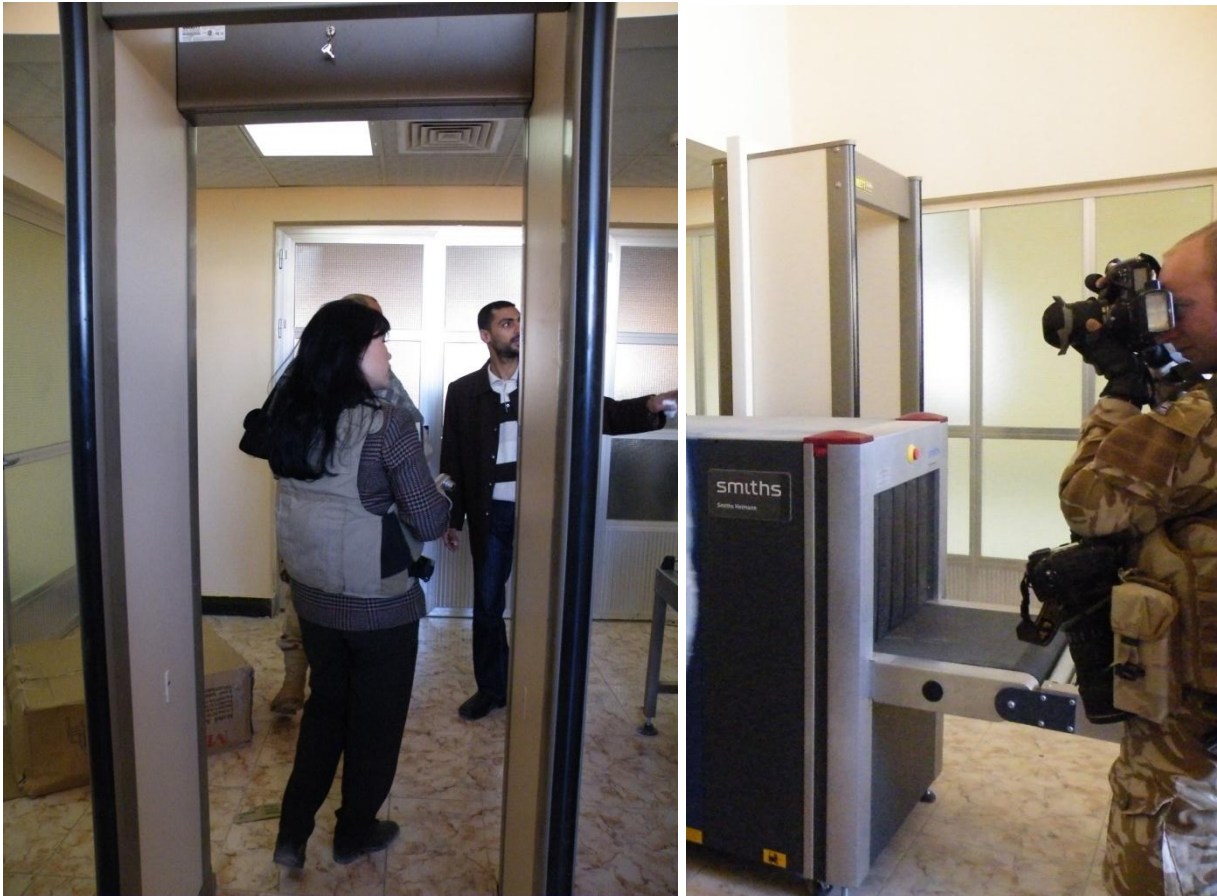
Since this courthouse will be used to hear serious crimes, additional security features were designed to protect the court witnesses and staff in the courthouse and annex/witness protection buildings. For example, the entrance to the courthouse includes metal detectors and scanners (Site Photos 22 and 23). In addition, a CCTV system, consisting of exterior cameras located throughout the building, is monitored by security officials at a centrally located kiosk in the annex building (Site Photo 24).

**Site Photos 22 and 23. Courthouse building metal detector and scanner**

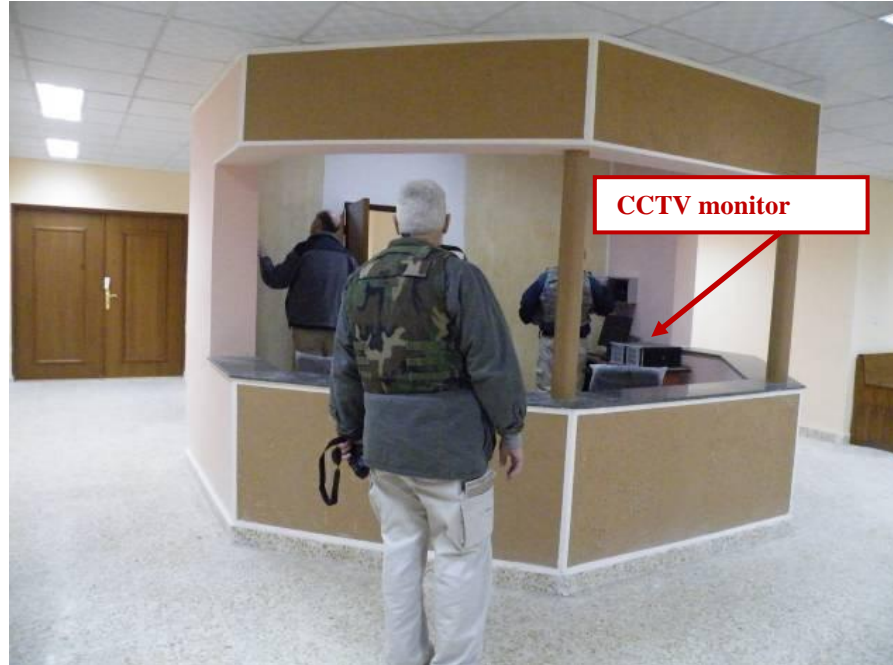
**Site Photo 24. Central kiosk with CCTV monitor**

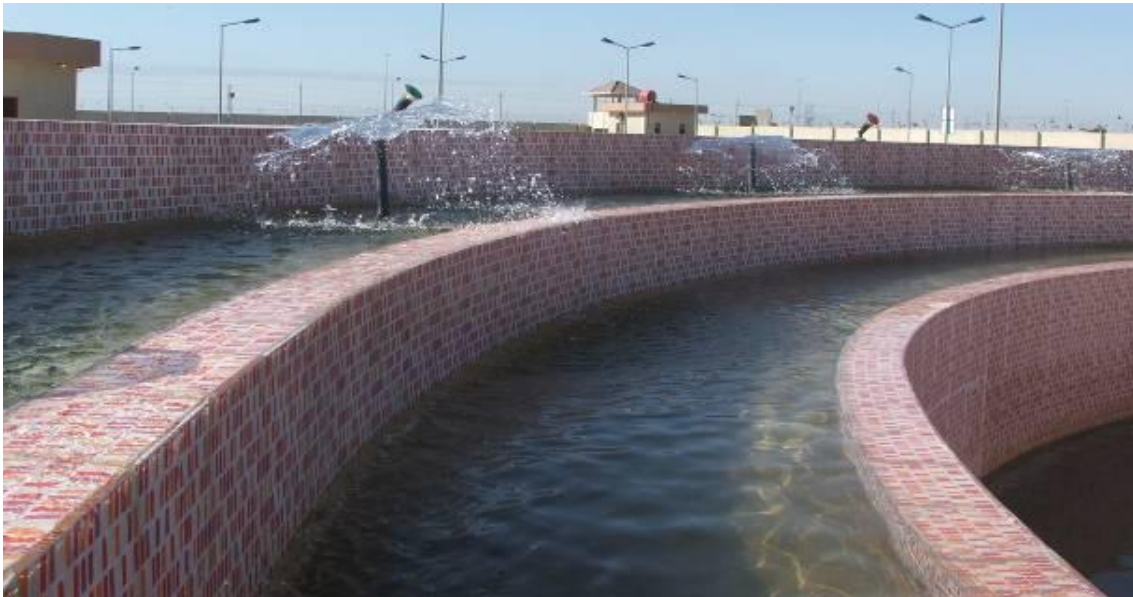
The site work included a decorative fountain surrounding a flag pole, which the contractor donated (Site Photo 25). The attractive fountain is located between the public parking area and the main courthouse entrance. Visitors can enjoy the relatively long walk between the parking lot and the courthouse by viewing the fountain or stopping at the kiosks located nearby.

During the site visit, courthouse personnel turned on the fountain, which SIGIR found to be working properly.

**Site Photo 25. View of decorative fountain**

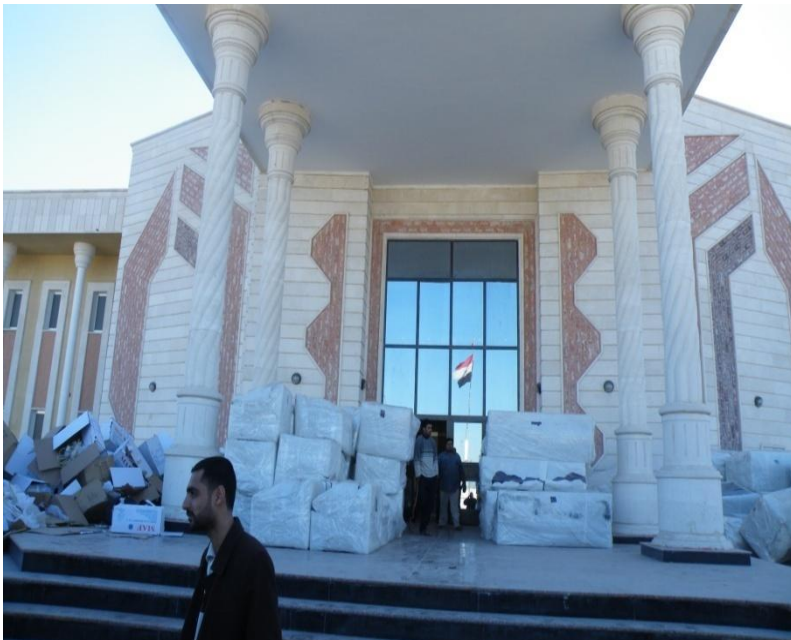
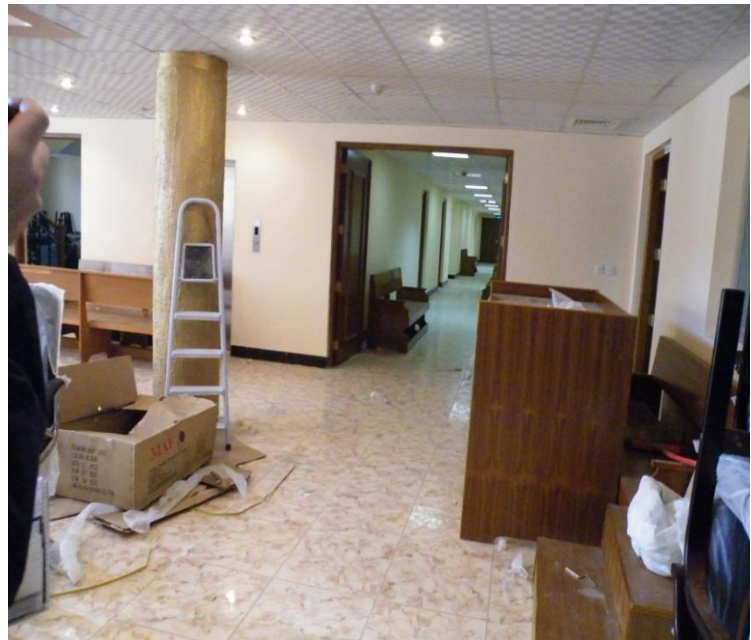
Even though the MOJ Higher Judgment Council officially accepted the courthouse and annex facilities on 25 September 2008, prior to SIGIR’s site visit the courthouse was unoccupied due to the lack of furniture. However, during SIGIR’s site visit, GOI-funded furniture was delivered and in the process of being assembled and arranged within the individual courthouse rooms (Site Photos 26 and 27). The furniture consisted of judges’ benches, chairs, waiting benches, leather sofas, and coat racks.

While not part of the assessment, SIGIR inspected the furniture already assembled and found it to be high quality. This furniture will provide the courthouse judges, judicial and administration staffs, witnesses, and prisoners with comfortable working and living accommodations.

**Site Photos 26 and 27. GOI-provided furniture dropped off outside and being installed inside the courthouse building**

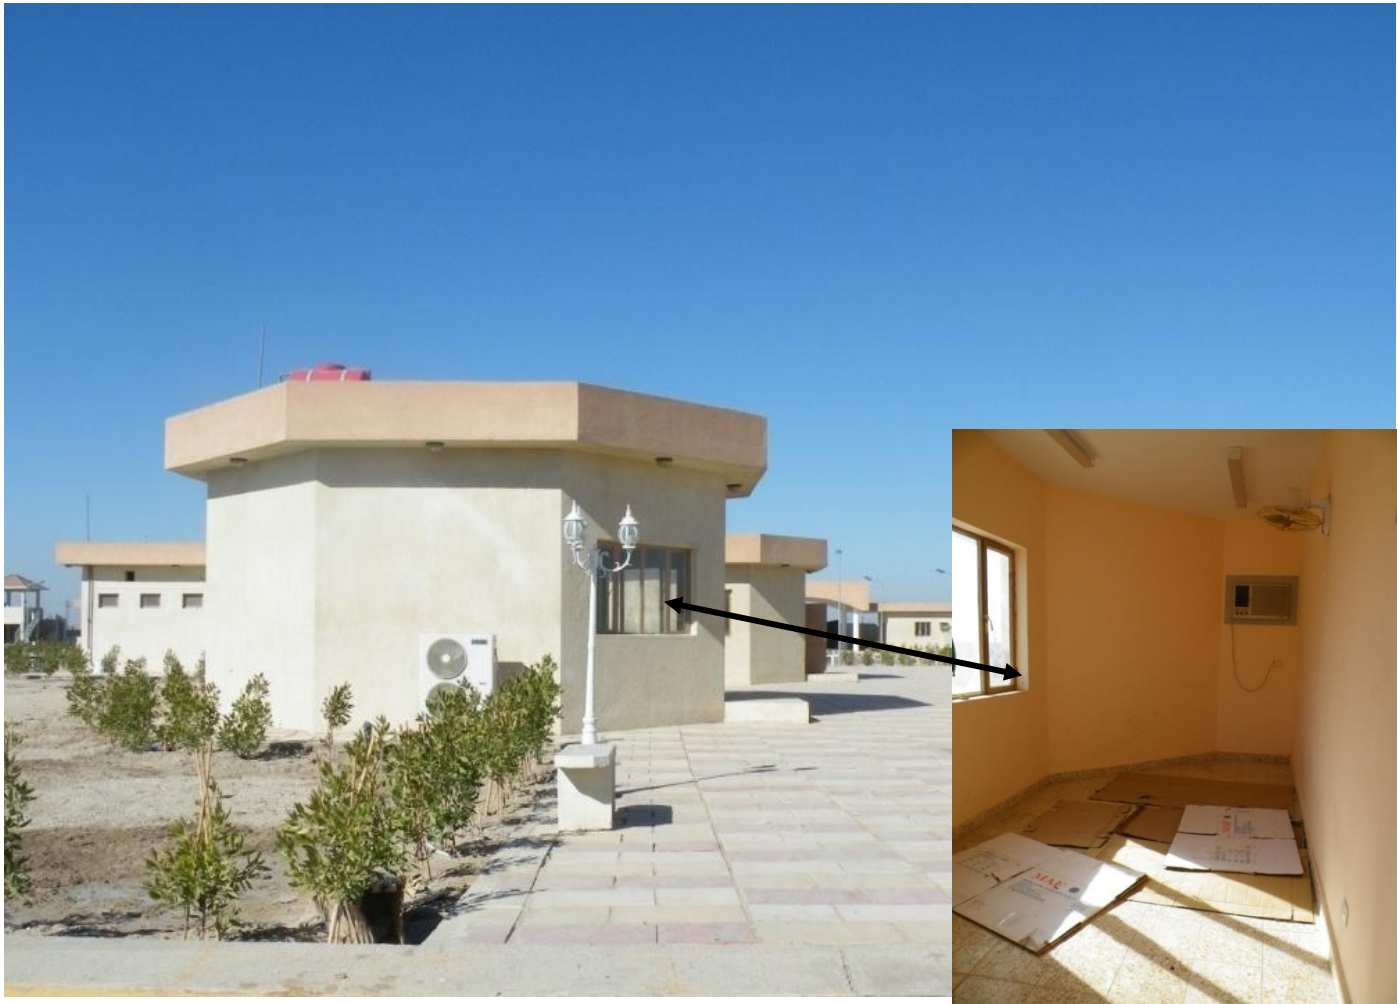
The courthouse facility design called for the construction of six kiosks to support the courthouse’s operations (Site Photo 28). The kiosks were generically designed as single-story, self enclosed rooms. Each kiosk is divided equally into two rooms, approximately 5.5m long by 2.5m wide, with each room having its own entrance. The interior of the kiosks consists of a window air-conditioning unit, wall fan, and ceiling lights.

**Site Photo 28. Exterior and interior views of the future concession stand kiosks outside the courthouse building**

According to GRS personnel, the kiosks will be used by the MOJ for a variety of purposes. For instance, some of the kiosks will serve as offices for clerks who will provide (for a fee) photocopies of official court transcripts and documents. In addition, the MOJ will rent the remaining kiosks as small shops or concession stands to supply food and drinks for court participants, visitors, and staff. According to courthouse personnel, the income generated will be used to fund routine maintenance for the courthouse and annex buildings.
